# An Amateur's Reconstruction of TWA Flight 260 Accident

Cliff Giles

February 2, 2018

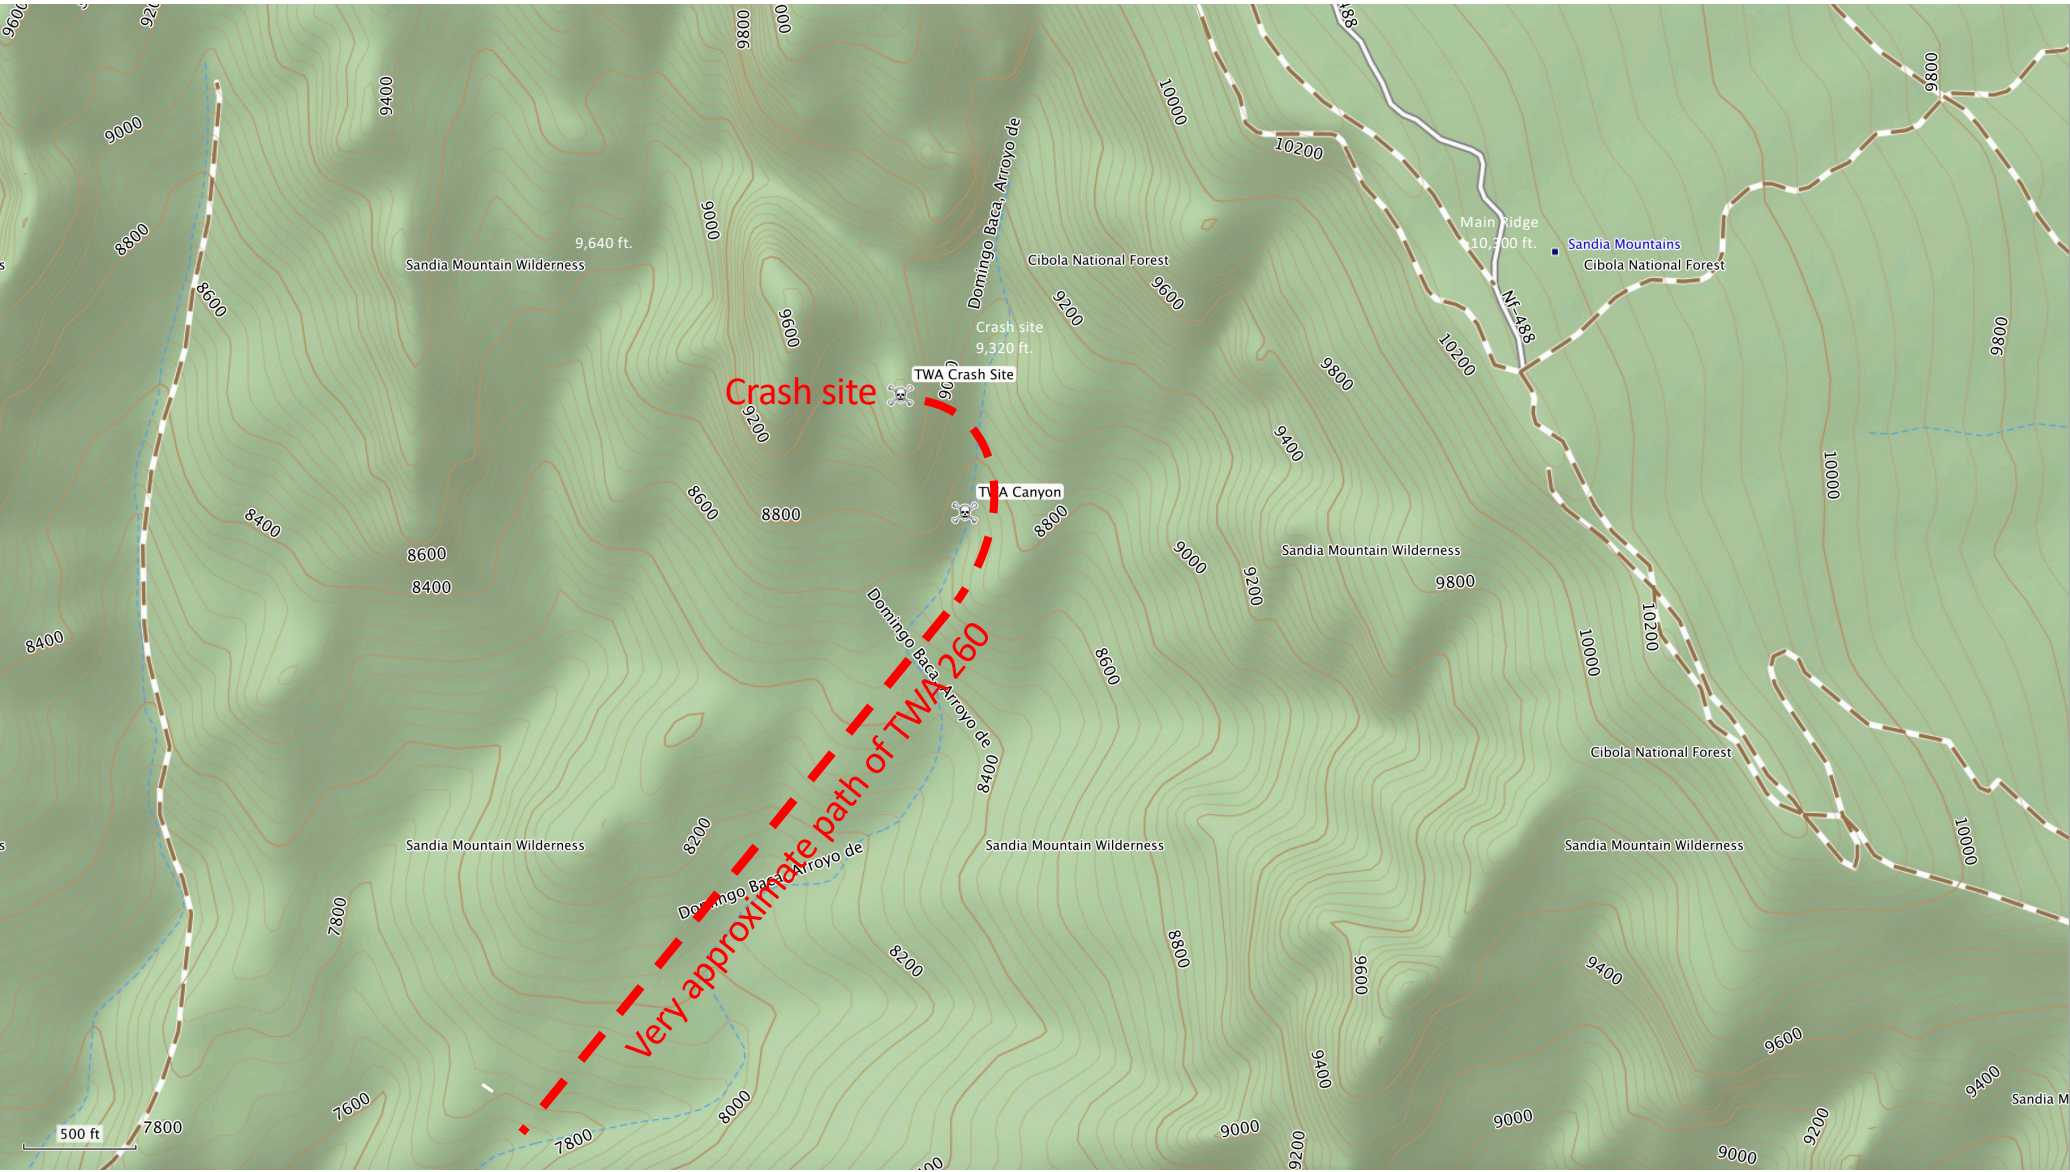
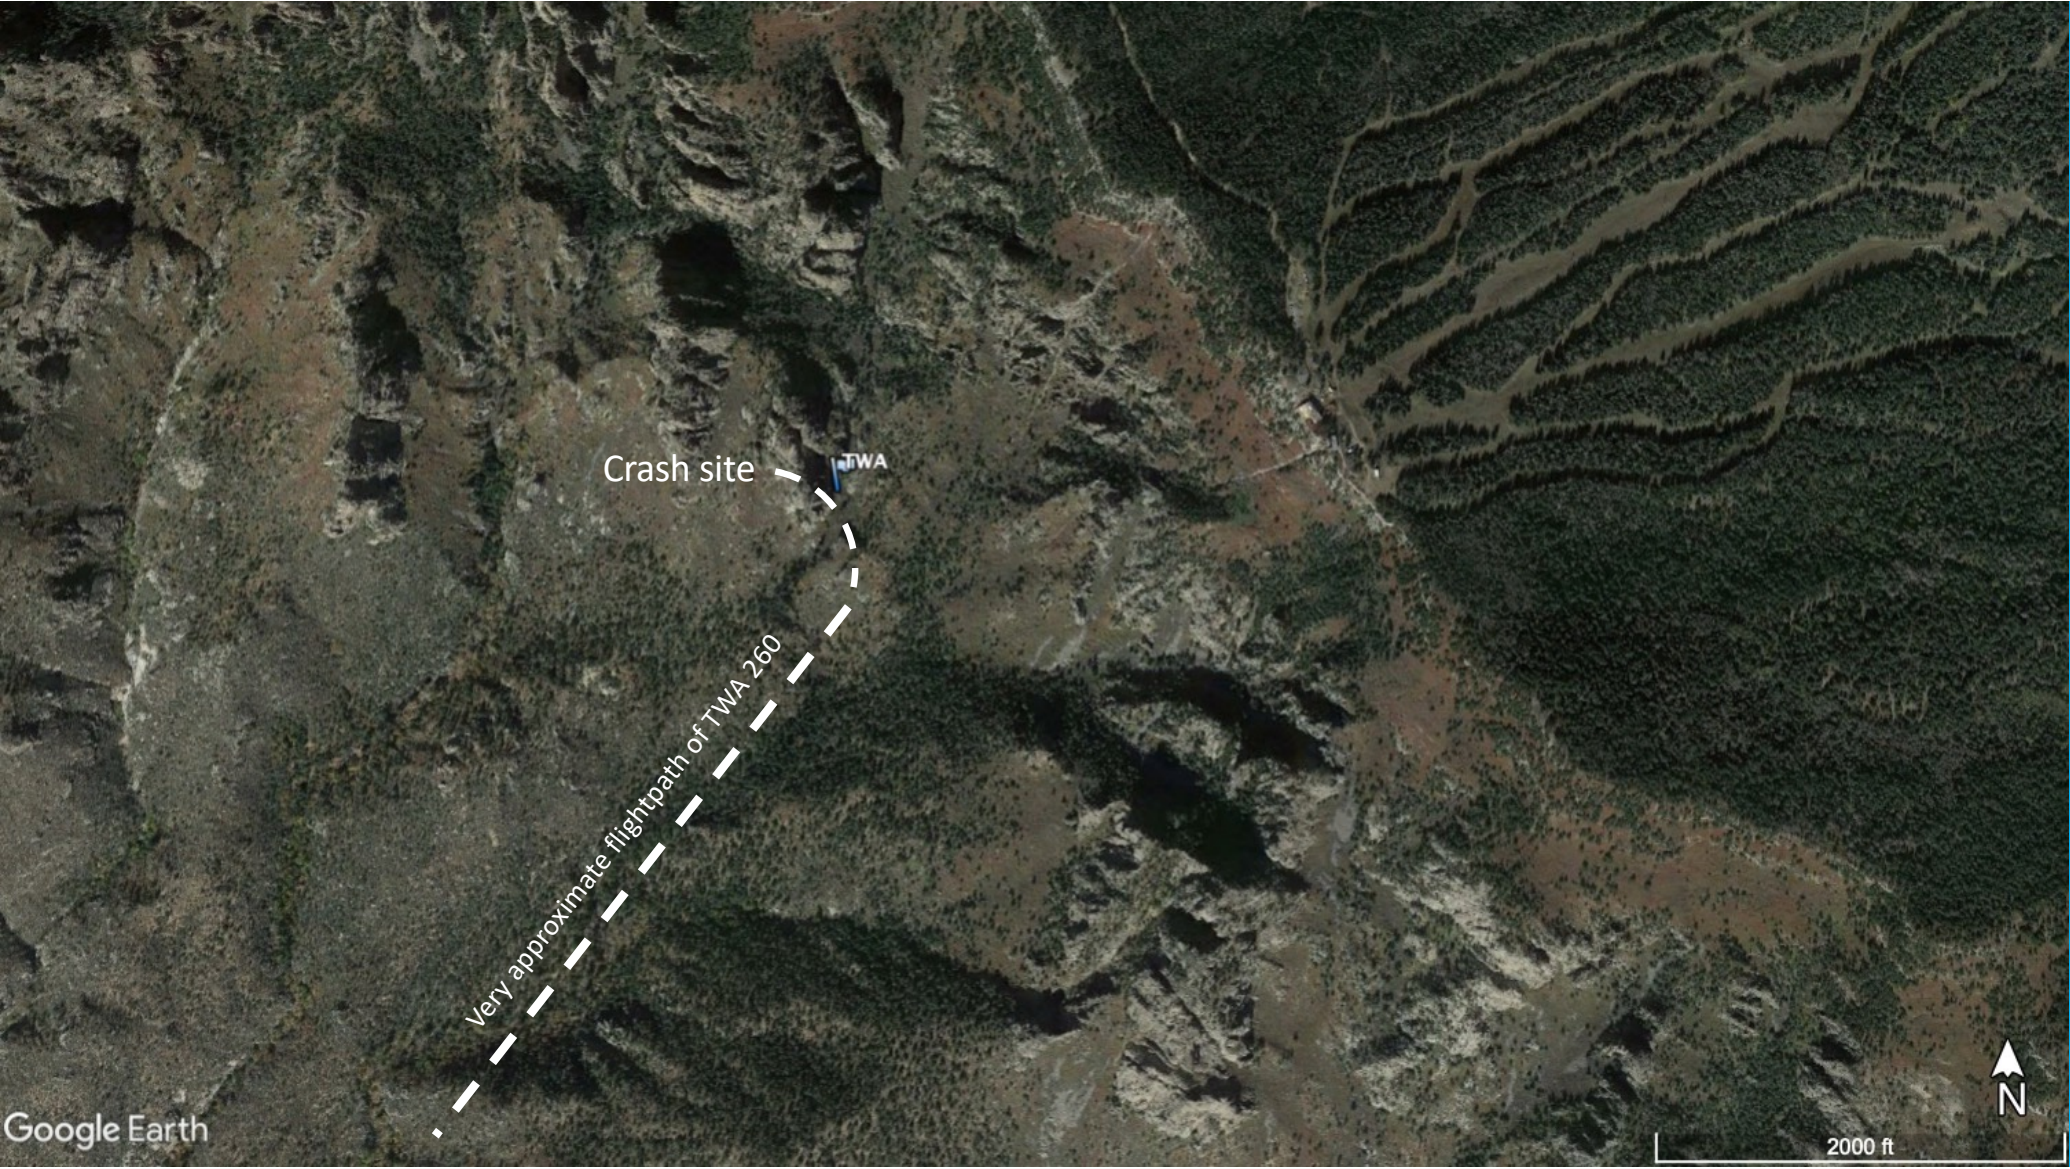
Very approximate flightpath of TWA 260

- Observer on ground north of airport saw plane passing in and out of clouds
- Climbed to 9000 feet as cleared
- Pilot failed to make turn to north at intersection with RWY 35 backcourse localizer
- Pilot almost succeeded in doing a climbing counterclockwise 180-degree turn when main Sandia ridge observed
- Crashed into lower ridge at 9300 feet heading 320 degrees (northwest) with fuselage pointing west (uncoordinated turn)

Crash site  
9,320 ft.

Main Ridge  
>10,300 ft.
