# An Amateur's Reconstruction of TWA Flight 260 Accident

Cliff Giles

February 2, 2018

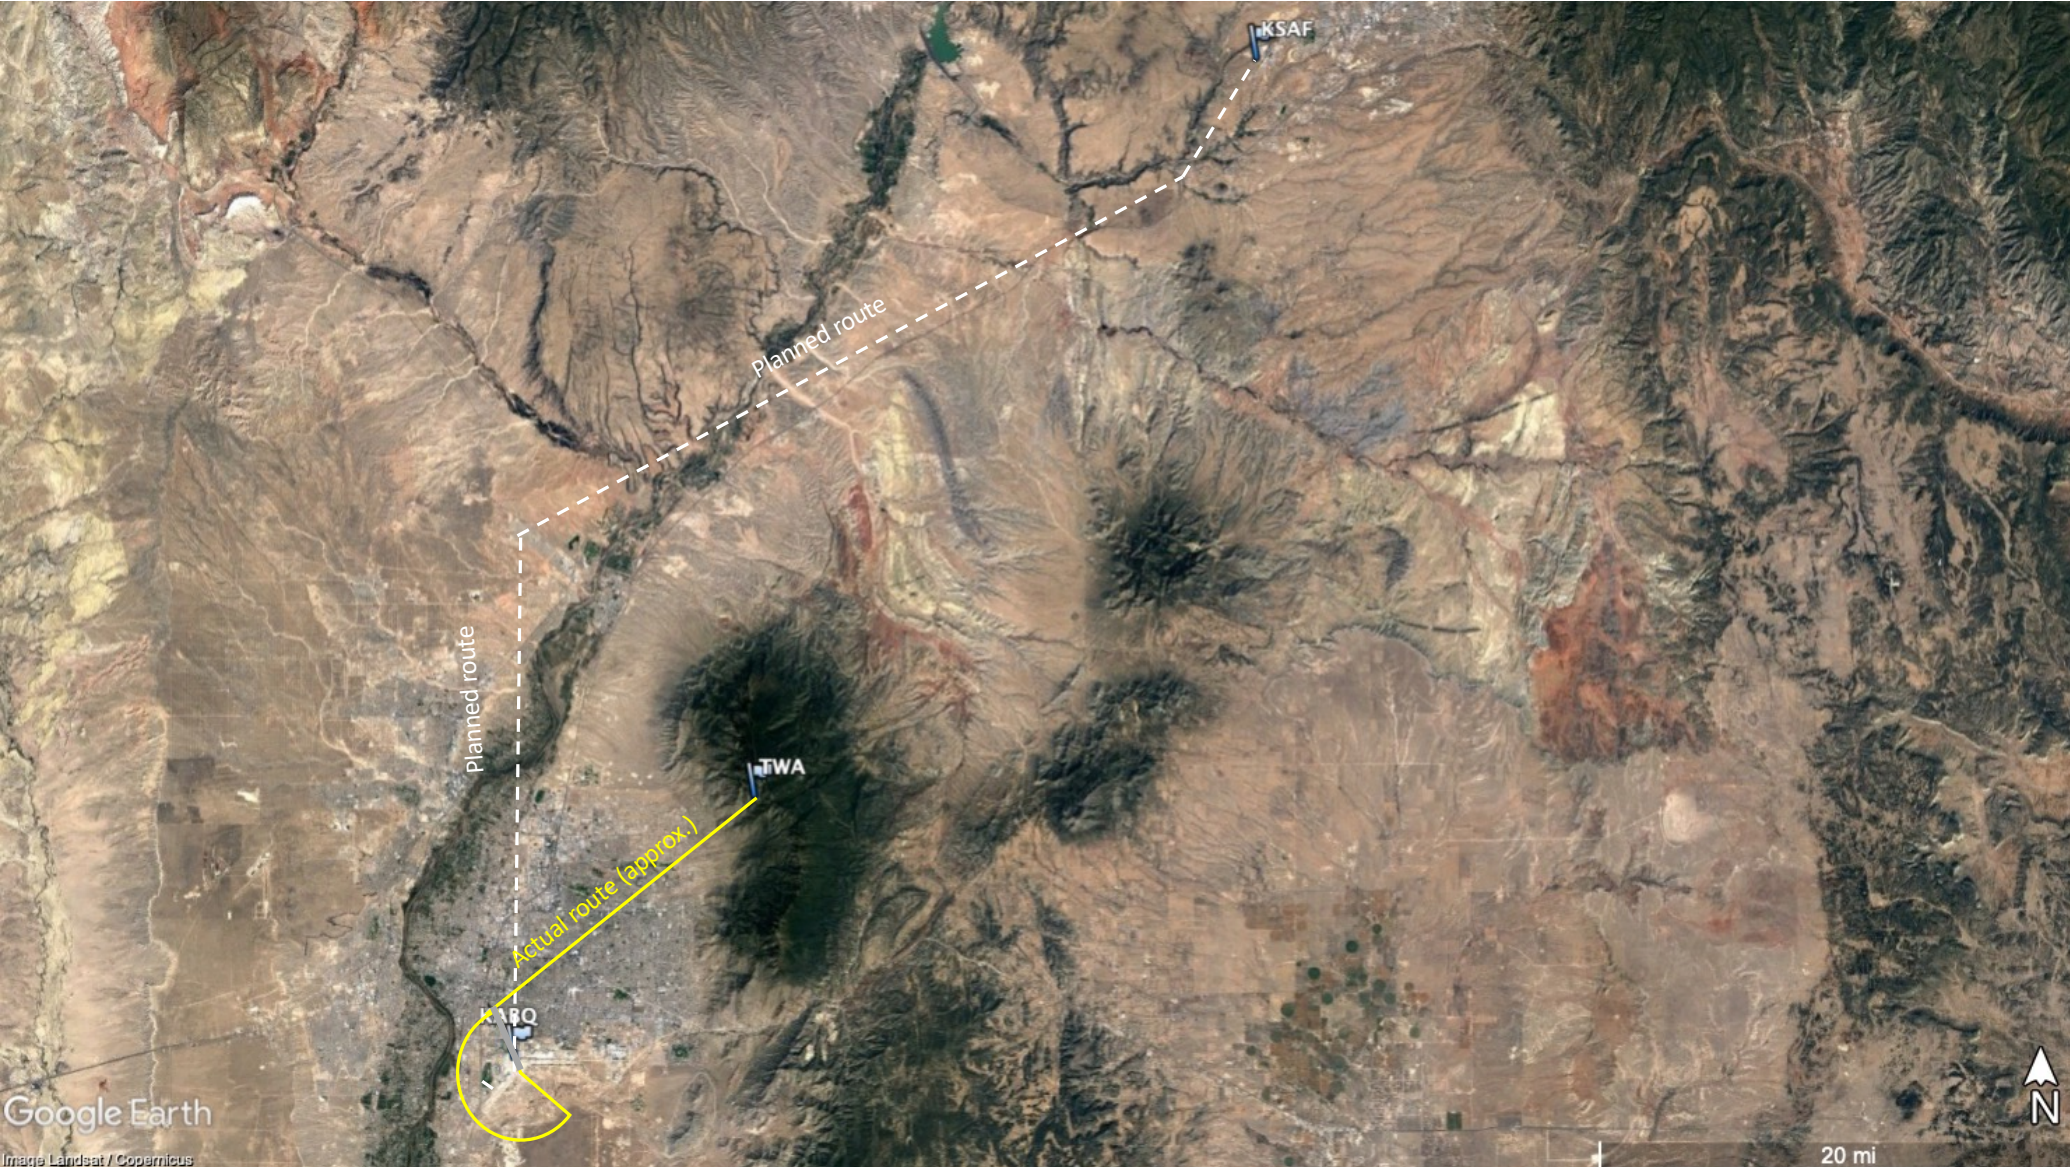
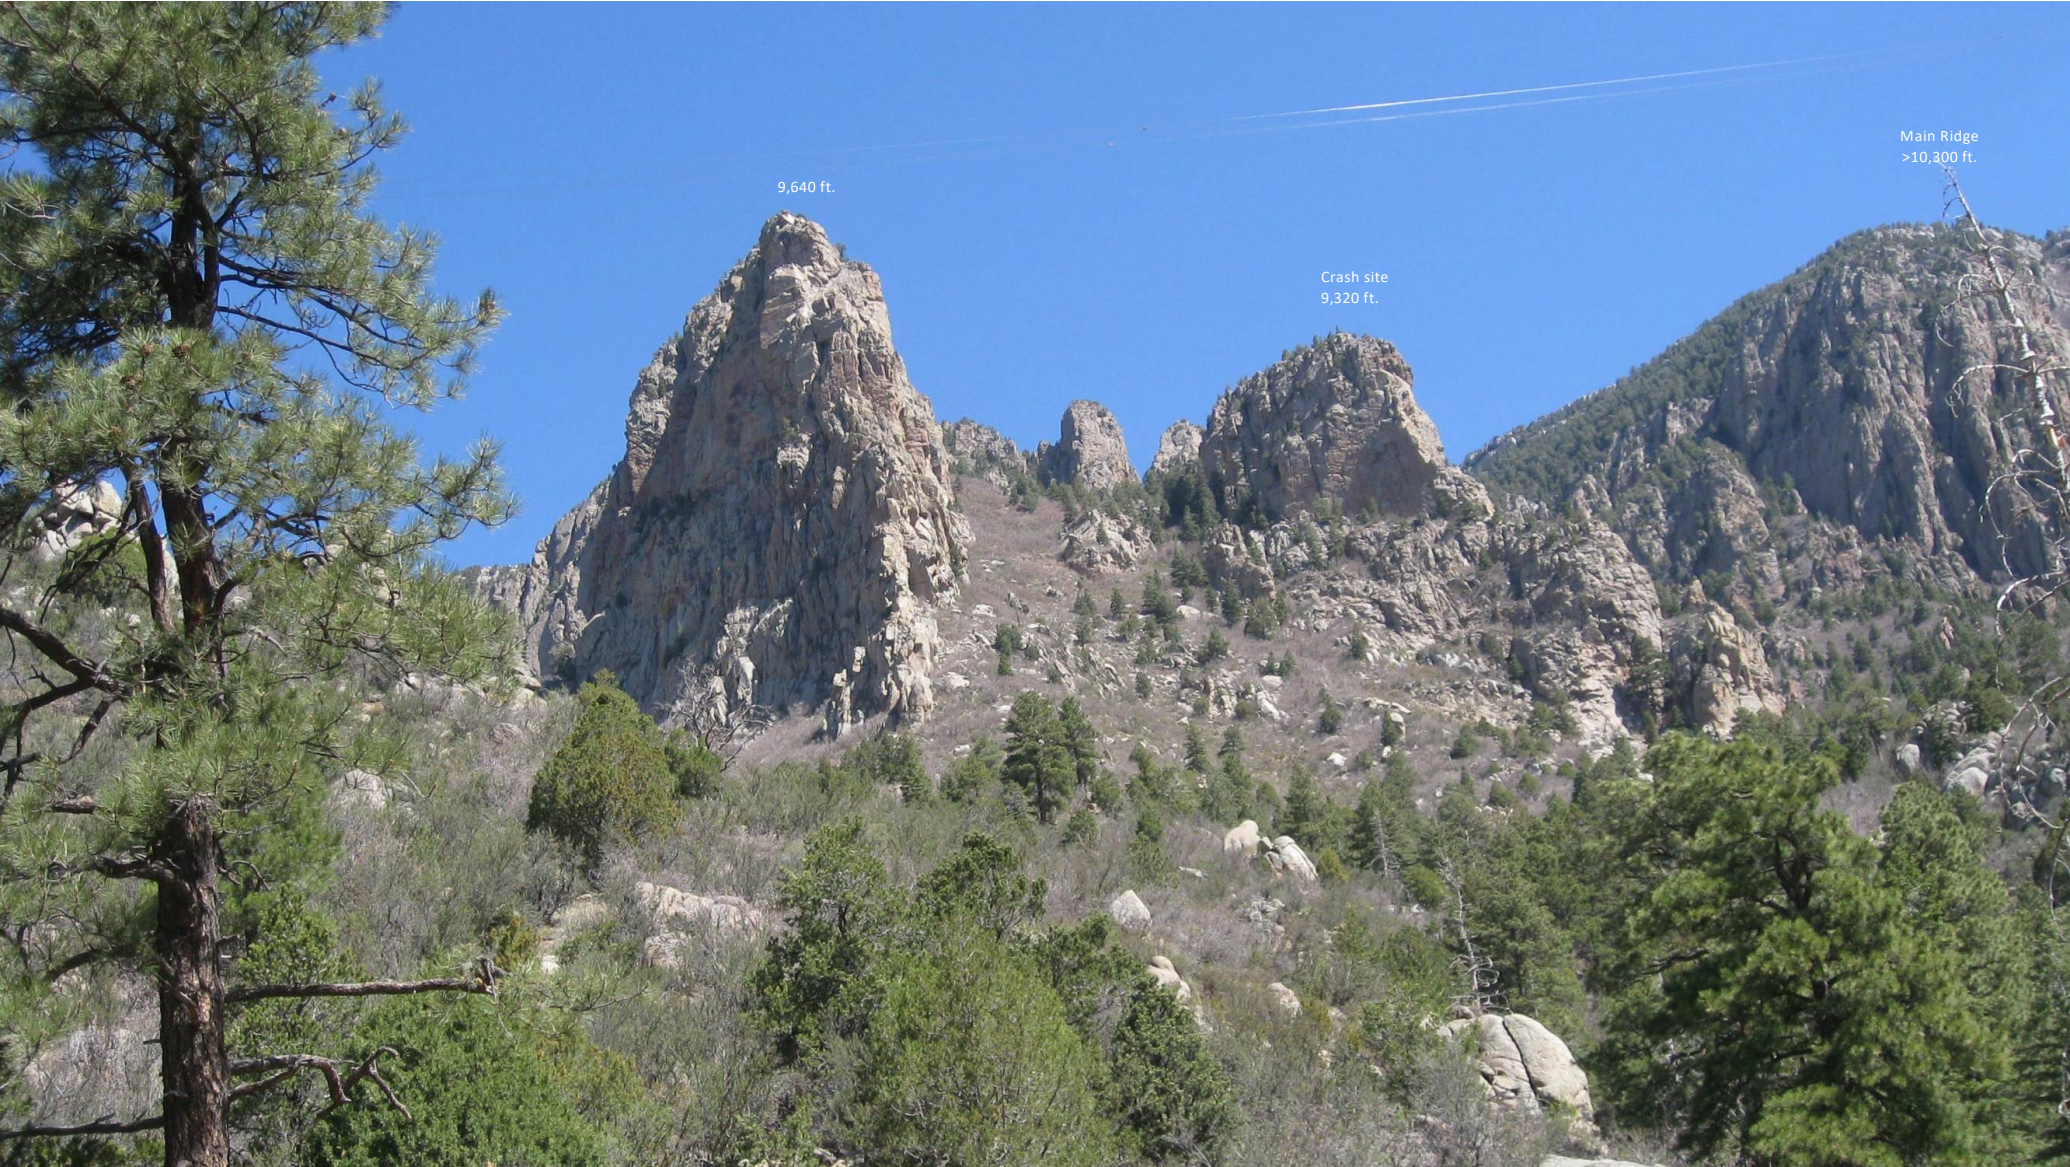
- Observer on ground north of airport saw plane passing in and out of clouds
- Climbed to 9000 feet as cleared
- Pilot failed to make turn to north at intersection with RWY 35 backcourse localizer
- Pilot almost succeeded in doing a climbing counterclockwise 180-degree turn when main Sandia ridge observed
- Crashed into lower ridge at 9300 feet heading 320 degrees (northwest) with fuselage pointing west (uncoordinated turn)

9,640 ft.

Crash site  
9,320 ft.

Main Ridge  
>10,300 ft.
